PENNSYLVANIA
VIRGIN RUN DAM

NDS I.D. No. PA - 00196
PENNDER I.D. No. 26 - 85

PHASE I INSPECTION REPORT
NATIONAL DAM INSPECTION PROGRAM

AUGUST 1979 1 7

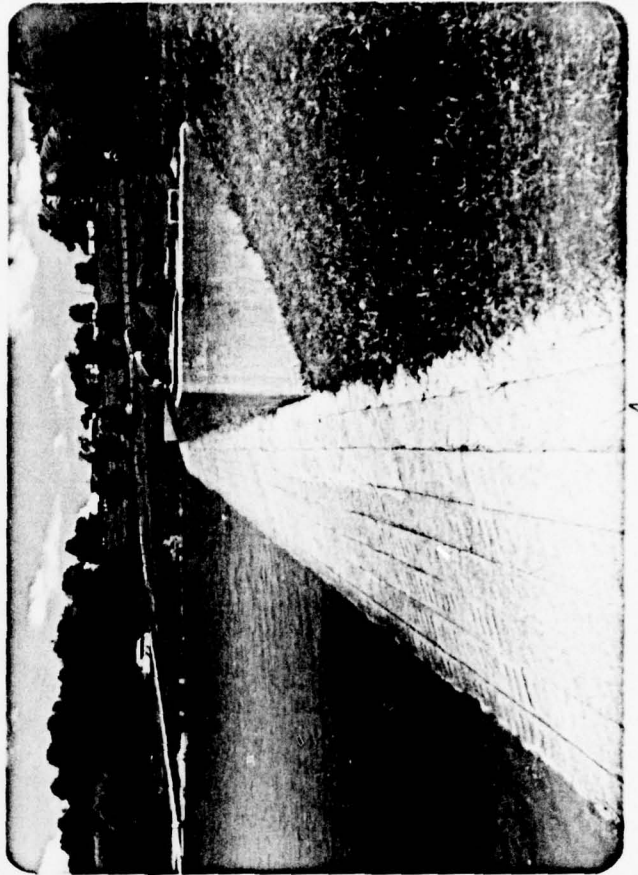
The dam is 10 feet wide at the crest and has slopes of roughly 3H:1V upstream and 2.5H:1V downstream. Field measurements indicate that additional material was placed along the crest, increasing the top width from the design 8 feet and locally steepening the upper portions of both the upstream and downstream embankment slopes. The upstream face is protected from wave action by a layer of hand-placed concrete block riprap, 8 inches thick, resting on a 6-inch layer of gravel or crushed stone. The riprap layer extends 2.5 feet below and 3 feet above normal pool (see Figure 3 and Photograph 4).

PHOTOGRAPH 4 View of the upstream embankment slope and control tower riser as seen from the right abutment.

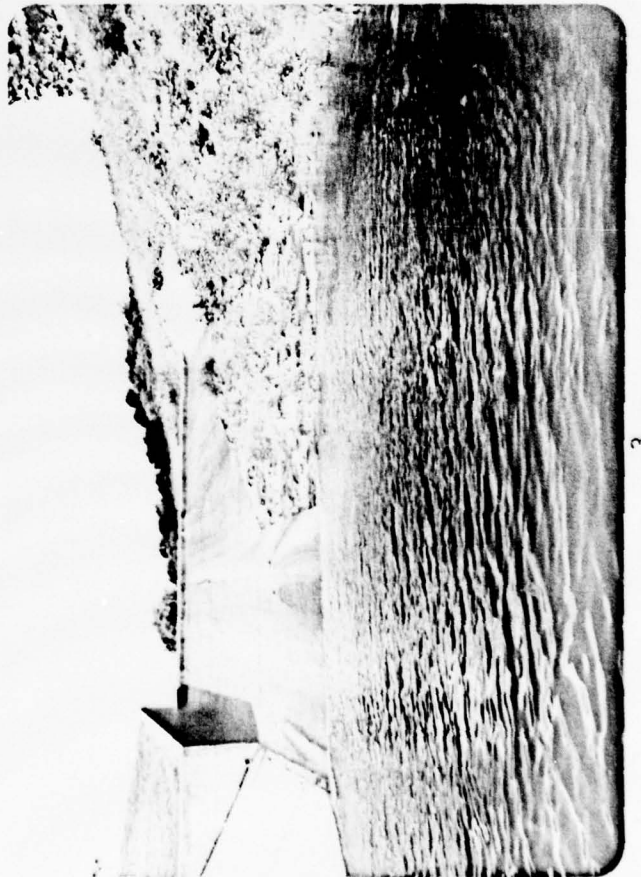
1. Spillway. The visual inspection revealed the spillway to be in fair condition. Minor cracking was observed along various portions of the spillway channel floor and sidewalls. For the most part, the larger cracks were sealed and filled with bitumen. The inspection team probed the area beneath the concrete spillway floor slab with a standard 6-foot rule and found extensive voids, some in excess of the rule length (see Figure 1). Some undercutting of the right spillway endwall, just beyond the plunge pool, has also occurred.

PHOTOGRAPH 3 View of the spillway channel as seen from the edge of the plunge pool.

b. Restore foundation support to the lower end of the right spillway endwall just beyond the plunge pool.

c. Reevaluate the present design and investigate the condition beneath the spillway channel floor to determine the extent of erosion which has contributed to a loss of foundation support and perform remedial work as deemed necessary.

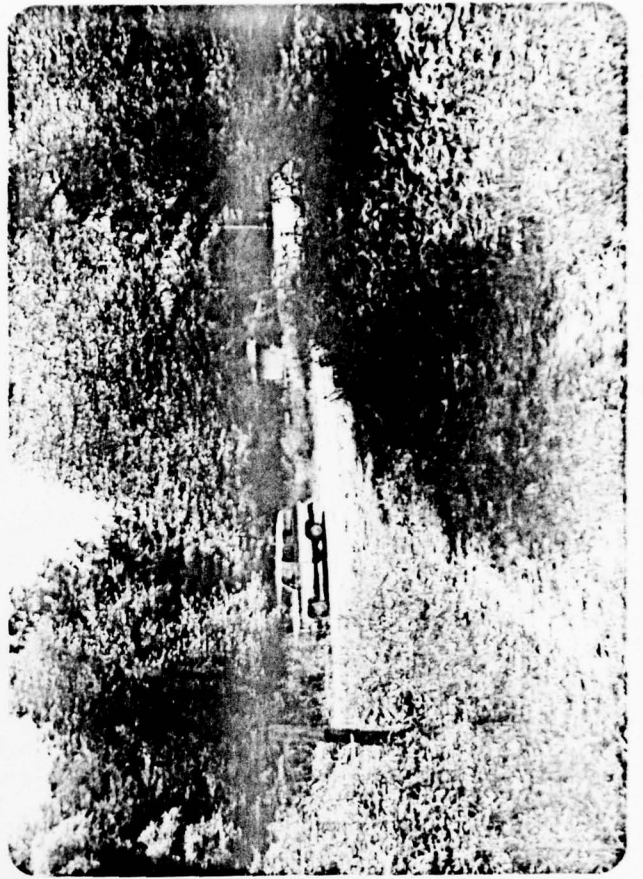
PHOTOGRAPH 8 View, looking upstream, of the dwelling situated nearest the stream located about 1,500 feet downstream of the embankment.

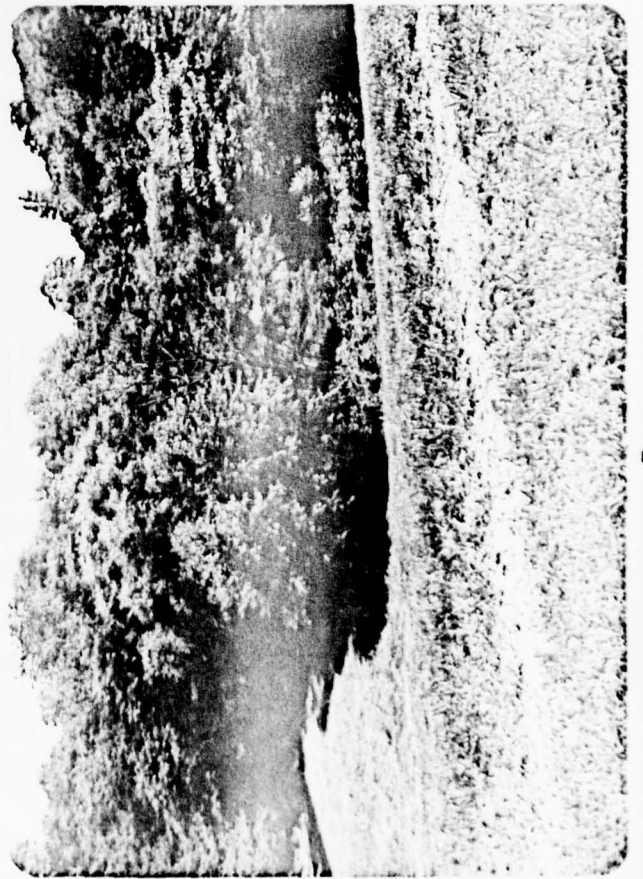
a. Embankment. Based on visual observations, the embankment appears to be in good condition. No evidence of seepage through the face of the embankment was detected nor were any signs of sloughing, erosion, excess settlements, or animal borrows observed. The heavy overgrowth along the downstream toe hinders expedient inspection of a most vital area of the structure. More importantly, such extensive overgrowth, if neglected for a long period, will deeply root itself into the embankment and present a potential structural hazard.

PHOTOGRAPH 7 View of the overgrown downstream embankment toe as seen from the embankment crest.

- a. Clear the downstream embankment slope and toe area (to a distance at least 100 feet beyond the embankment toe) of all trees and overgrowth that hinder visual evaluation of the facility.
- b. Restore foundation support to the lower end of the right spillway endwall just beyond the plunge pool.

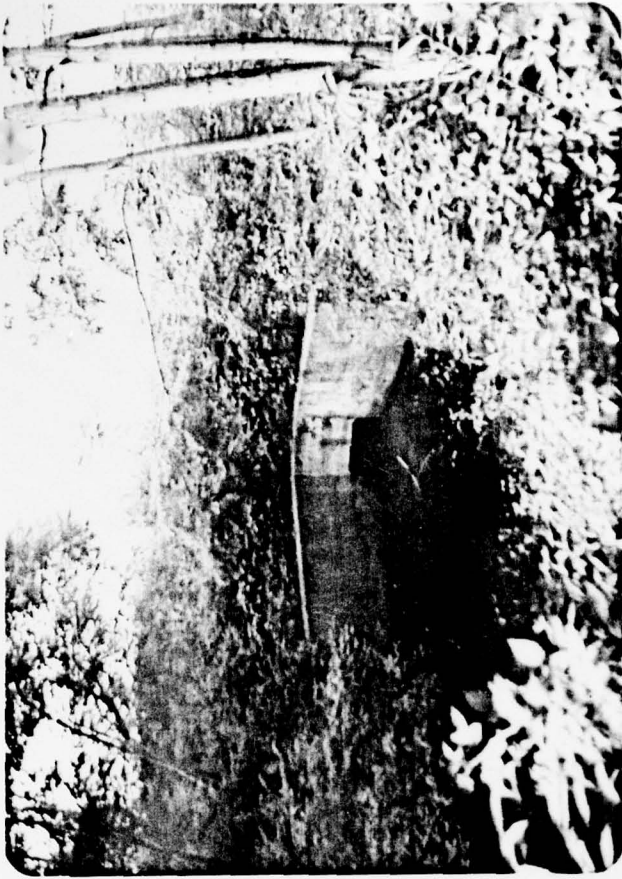
6

2. Outlet Works. The outlet works at Virgin Run Dam is in excellent condition. No signs of deterioration were observed on any of the visible exposed concrete surfaces, including a large portion of the interior of the control tower riser (see Photographs 4 and 5). The stop logs were in place although exhibiting some leakage. The 3-foot square discharge culvert could not be entered, however, due to tailwater and discharge through the stop logs (see Photograph 6).

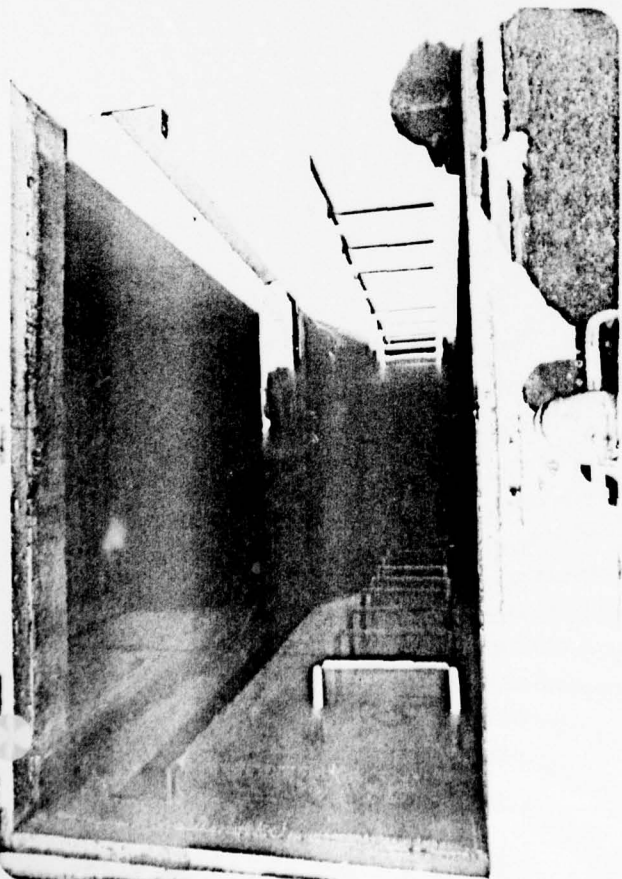
PHOTOGRAPH 5 Close-up view of the interior of the control tower riser.
